Testing of the Oztec Reinforcing Bar Shaker

**The University of Tennessee
Department of Civil and Environmental Engineering
Knoxville, Tennessee**

FINAL REPORT

August 15, 2003

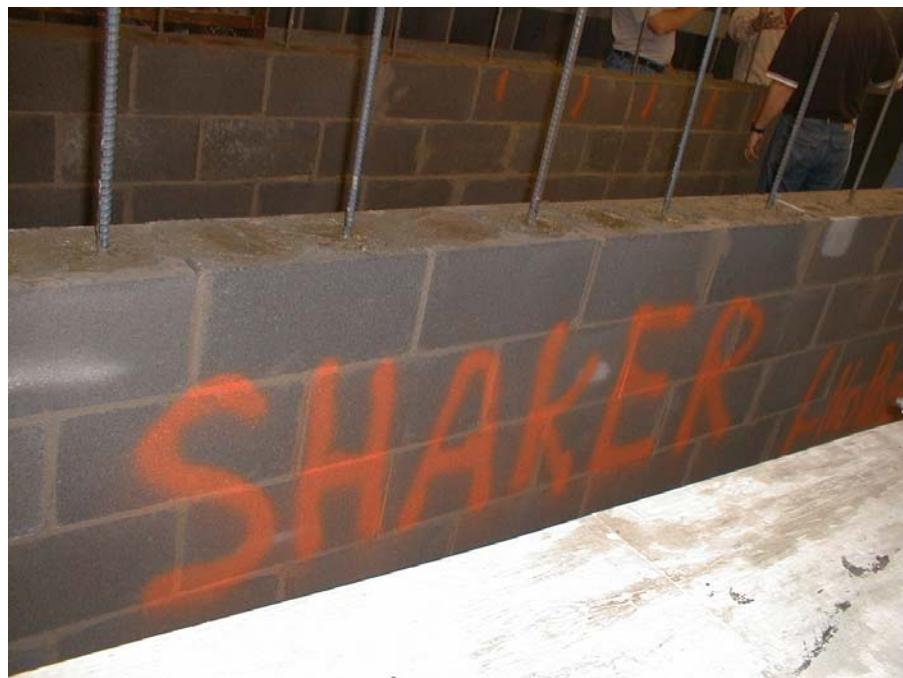
Figure 1. Completed wall prior to testing

Two masonry walls were constructed using standard 8 in. concrete block (CMU) units. Each wall was 3 ft – 4 in. high (5 courses) 14 ft – 8 in. long. Alternate cells contained a reinforcing bar. Five #4 Grade 60 bars and five #5 Grade 60 bars were placed in each wall. The wall was constructed with Type N masonry cement mortar by an experienced mason. The day after construction the walls were grouted with a coarse grout having a design strength of 3000 psi and a measured slump of 9 inches. The grout was consolidated in one wall using a pencil vibrator and in the other wall using a Oztec Rebar Shaker. Six cells in each wall (three with #4 and three with #5) were reconsolidated according to specification. The remaining bars were not reconsolidated in order to check the effects of a construction error of not reconsolidating as required. A picture of the completed wall is shown in Figure 1.

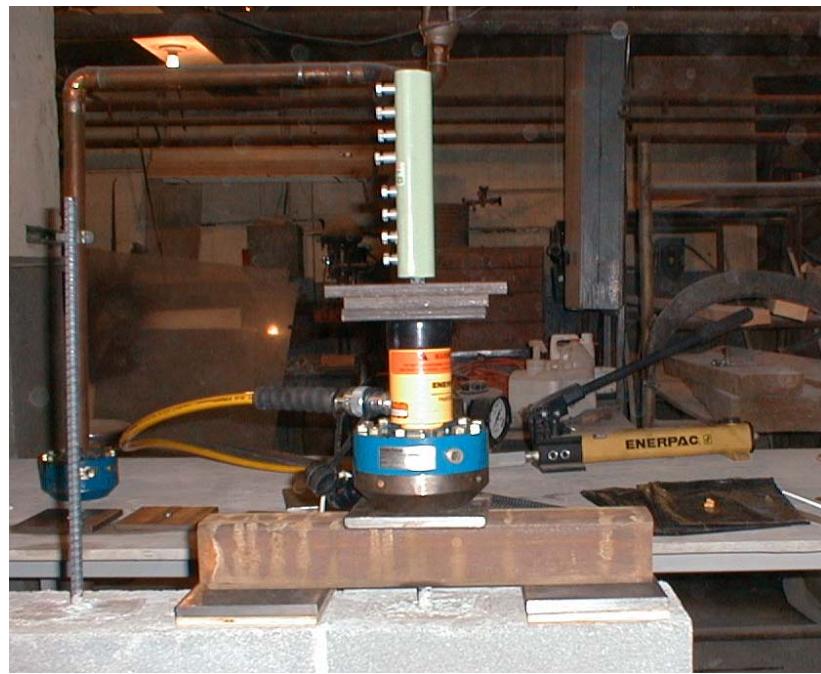
Figure 2. Test Set-up

A pullout test was conducted on each bar. The set-up consisted of 0.5 in. steel bearing plates with 0.5 in. plywood bearing pads placed on each side of the cell with the reinforcing bar. A 3 in. structural tube spanned between the bearing plates and had a hole in the center for the reinforcing bar to pass through. A load cell was placed on the tube followed by a hydraulic jack. A mechanical reinforcing bar splice was used to provide a bearing surface on which to push up on the reinforcing bar. Steel plates were used to take up any slack and provide bearing surfaces. While testing the #4 bars, split steel plates were added as needed when the travel length of the hydraulic ram was exceeded. A picture of the test set-up is shown in Figure 2.

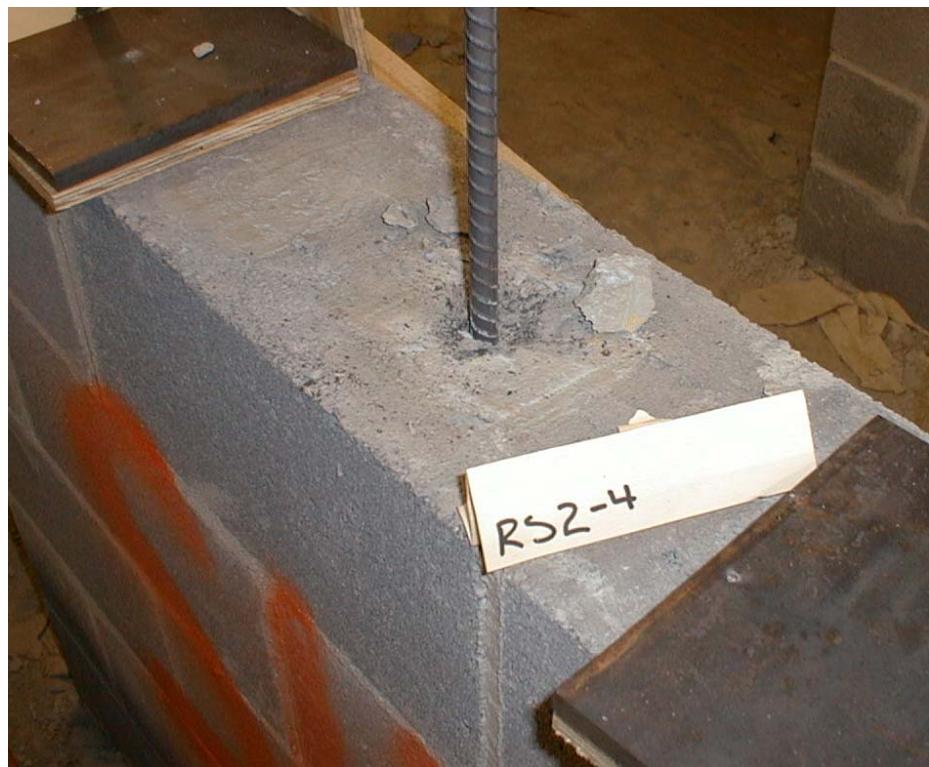
Figure 3. Typical small cone of grout that failed during testing of #4 bars

Complete results of the testing are given in Table 1. The #4 bars were tested until failure. In all cases the bar ruptured. Thus, the grout was sufficiently consolidated to develop the full failure strength of the bar. A small cone of grout about 0.5 in. deep would typically fail around the top of all #4 bars. This was most likely due to the yielding and elongation of the bar as it was being tested. A picture of this is shown in Figure 3.

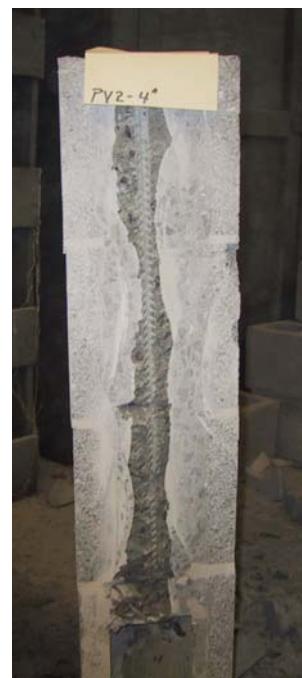
Figure 4. Wall cross-section with pencil vibrator consolidation

After the pullout testing was conducted, the walls were cut apart with a masonry saw to examine the condition of the interface between the grout and reinforcing bars and to inspect for any voids. Typical pictures from the pencil vibration wall are shown in Figures 4 and 5. Note that there are no voids, good bond between the grout and the masonry units, and the reinforcing bar indentations are clearly visible in the grout. Similar results were obtained when using the reinforcing bar vibrator. Figures 6 and 7 show the wall cross-section with a #5 bar. Figure 8 shows the wall cross-section with a #4 bar. There again are no voids, good bond between the grout and the masonry units, and the reinforcing bar indentations are clearly visible in the grout.

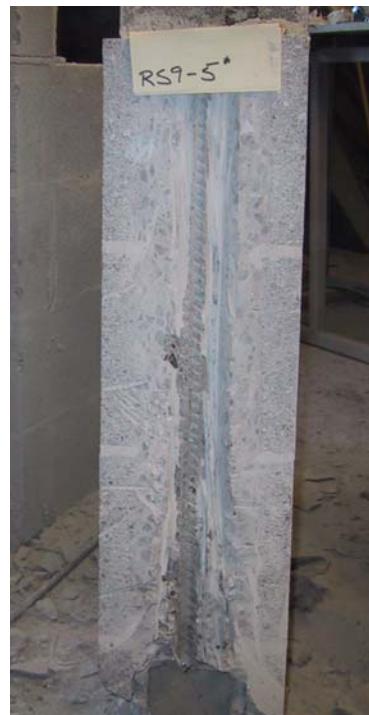
Figure 6. Wall cross-section with Oztec Rebar Shaker consolidation

No noticeable difference was observed in either the pullout strength of the bars or the condition of the grout when the grout was destructively examined between the cells that were consolidated only once, and those cells that were reconsolidated. This shows the effectiveness of the Oztec Rebar Shaker in that proper consolidation was achieved without reconsolidation. We do recommend that the current specifications be followed and that the grout be reconsolidated, but the Oztec Rebar Shaker performs the same as the pencil vibrator should reconsolidation be mistakenly omitted.

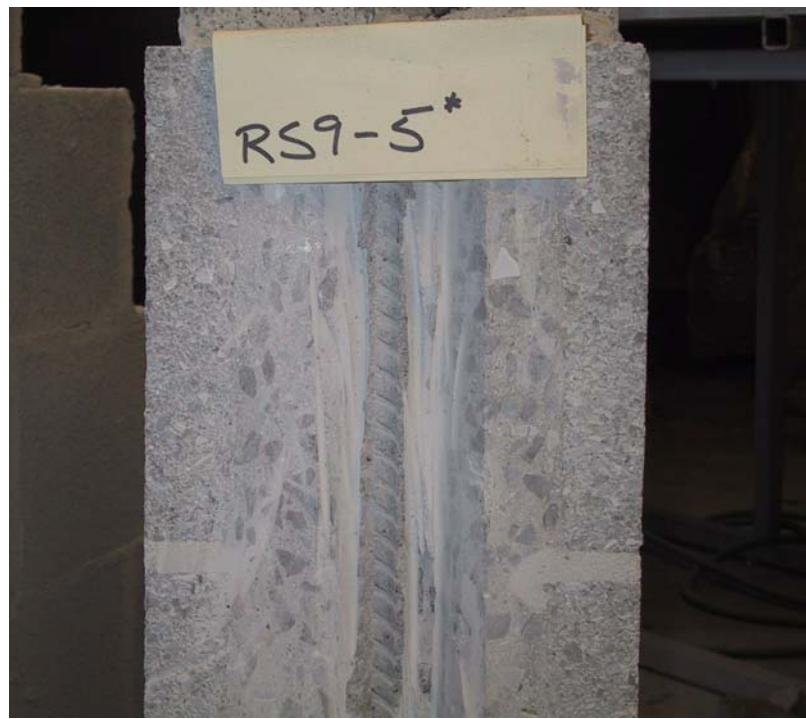
Figure 7. Wall cross-section with Oztec Rebar Shaker consolidation
