SB, Cardon holder for PG 280, 2024-03

Models affected: PG 280 (PG 280 S is not affected).

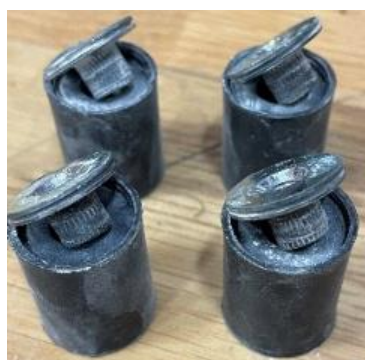
The ear bushings and/or shock absorbers have been worn out too quickly.

Figure 1: Broken 584816101

To improve the grind holder durability, the following changes were implemented:

1. Ears were changed to a wider model and the base plate so that the ears have more room to move.
2. The shock absorbers were changed to a better version.

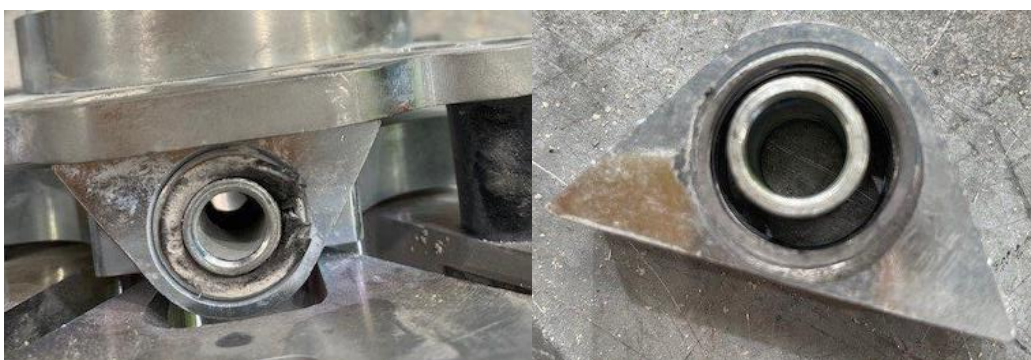
Figure 2: Examples of a broken 584816401

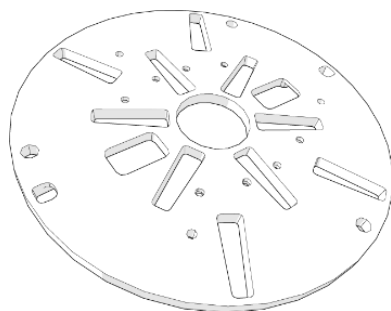
Figure 2: 546921001

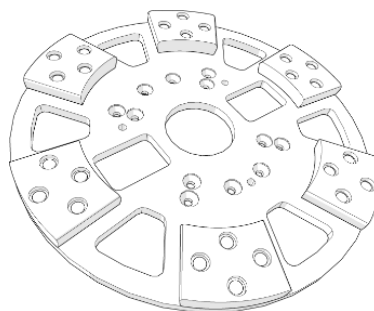
Figure 3: 538872301

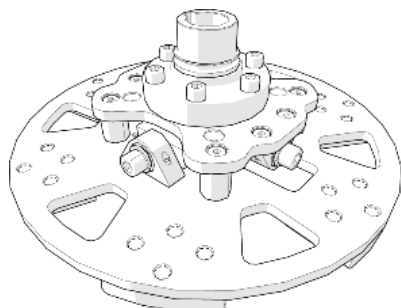
Figure 7: EZ Grind holder

With an EZ holder you can change the Bushing and fastener kit (547054701).

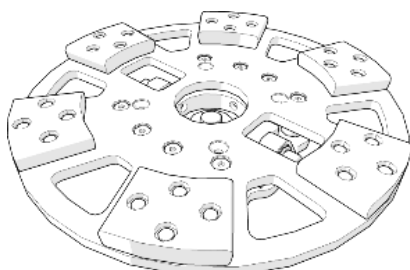
Figure 8: EZ Grind holder

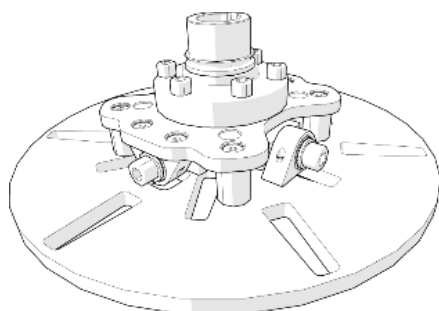
Figure 10: Redi Lock Tool Holder

With Redi Lock Holder (Fig.10) or Multi Tool Holder (Fig.11) you need to change the complete holder.

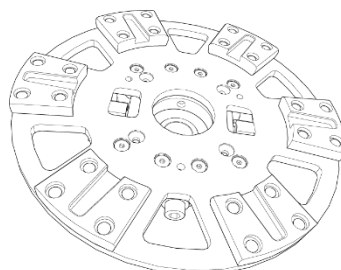
Figure 11: Multi Tool Holder

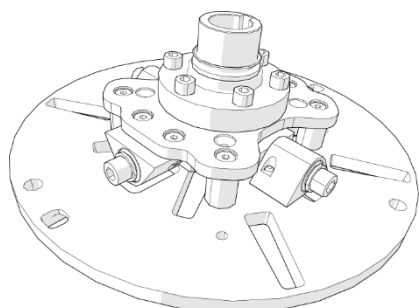
Figure 12: Redi Lock compl. 546137901

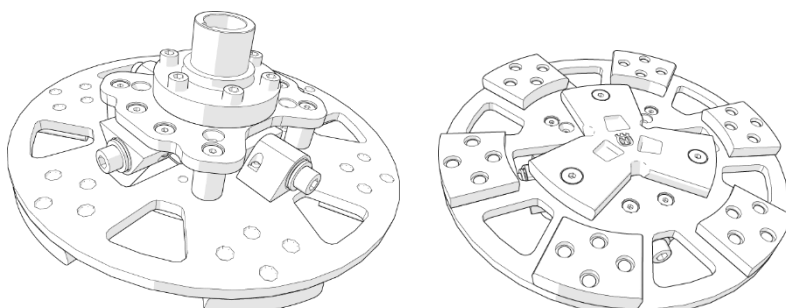
Figure 13: EZ compl. 546527301
